# LESSONS LEARNED FOR GAP CROSSING HIGH MLC VEHICLES

NO. 25-900  
December 2024

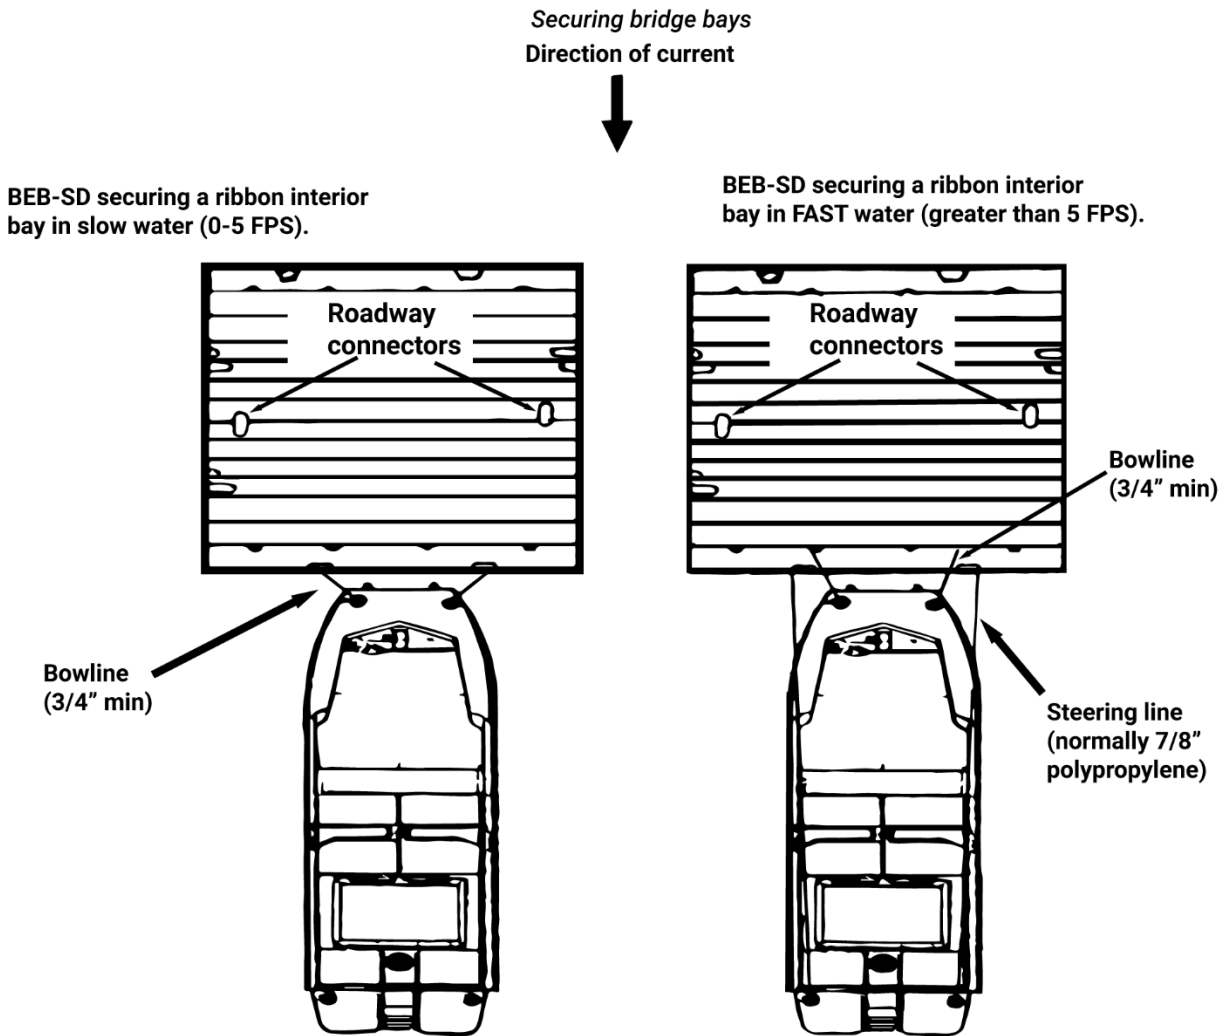
### Training Circular 5-210L Military Float Bridging Equipment<sup>1</sup>

## CAUTION

If the roadway/bow ponton bridge latches are not engaged, the bow ponton will fold up when a vehicle crosses the bridge.
